Manhole Inspection Summary

Manhole # S35M__011MH

Insp Date: **3/25/08 11:06 AM**

Location Address: **7 e. lee**

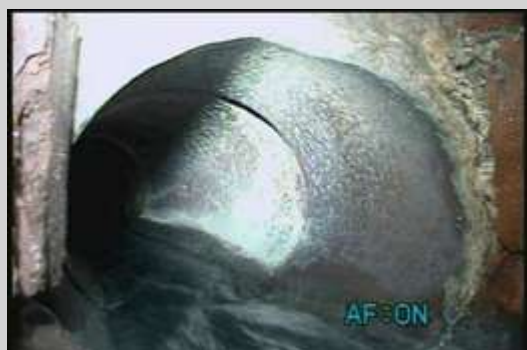
12 O'Clock Outflow

8 in. Circular Gravity Sewer
Pipe Out @ 12 O'Clock

Pipe Material: **Clay** ☐ Pipe Lined

Invert Depth: **12.58** (ft.) Flow Characteristics: **Fast**

Deposits: ☒ None ☐ Mud ☐ Sludge ☐ Debris ☐ Grease

Infiltration: **None** Pipe Seal Cond: **Unknown**

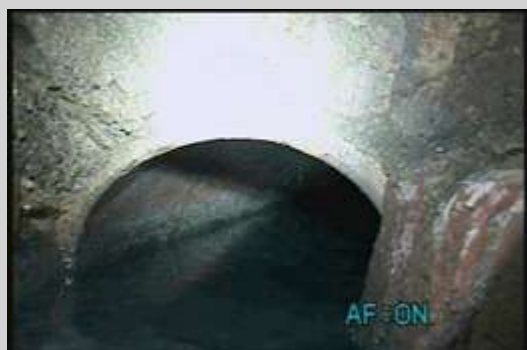
9 O'Clock Inflow

8 in. Circular Gravity Sewer
Pipe In @ 9 O'Clock

Pipe Material: **Clay** ☐ Pipe Lined

Infiltration: **None** Pipe Seal Cond: **Unknown**
